OFFICE OF THE MARION COUNTY SURVEYOR
SECTION RECORD CORNER

SECTION 13 TOWNSHIP 16 RANGE 4

DATE: 11-27-07

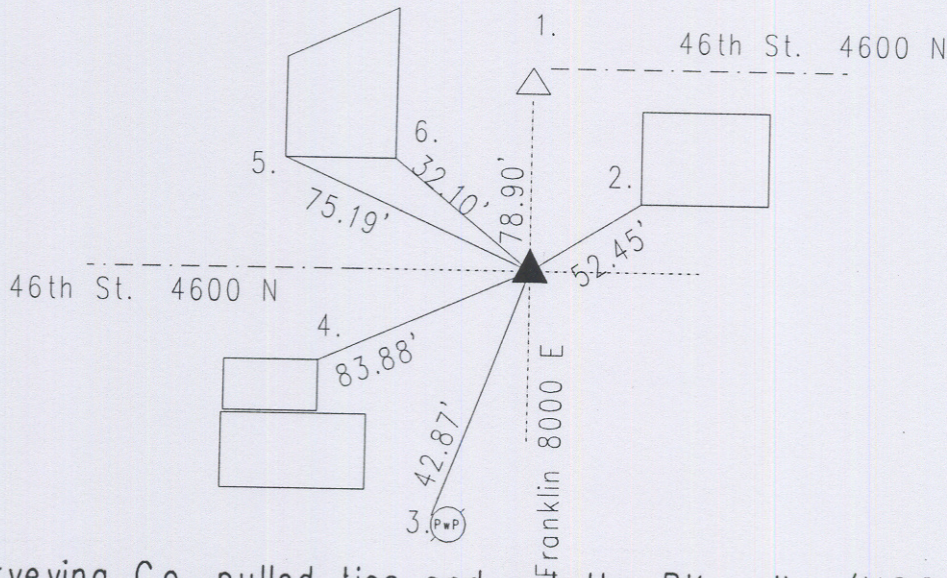
United Surveying Co. pulled ties and set the PK nail w/MCS washer in the wrong location. There was no evidence this corner had been used as a PHOTO MARK. April 4, 1994, Lee Miller reported this corner in ERROR on measured distances between corners to north and the PK nail w/washer as shown. The PK nail w/washer was NOT referenced as the corner by these ties. April 4, 1994, Wilcoxen re-checked these ties comparing them to older ties on file, and found the PK nail w/washer to be in the wrong location. Wilcoxen re-set a small PK nail at the edge of a manhole rim where 'old' ties intersected. The PK nail w/MCS washer was REMOVED at that time. The PK nail w/MCS washer was 0.95'S and 0.65'W of location RESET. Re-tied by Wilcoxen 7-8-99. Re-tied 8-4-02 by Wilcoxen.
